**Flood Control Project Maintenance
Levee Inspections**
LMA District Cover Sheet
Spring 2011 Levee Inspection Results

Reclamation District No. 2094 Wathal

Waterway			Bank	Unit Miles
Unit No. 01 San Joaquin River			Right	2.82
	Spring (March - May)	Summer (June - August)	(September - November) Fall	Winter (December - February)
Unit Maintenance Rating (Fall Only)				
Date of Inspection	4/12/2011 - 4/12/2011			
DWR Inspector	Jim Eto			
Accompanied By	Brian Mizuno RD 2094

Levee Inspection Report By Mile - Spring 2011

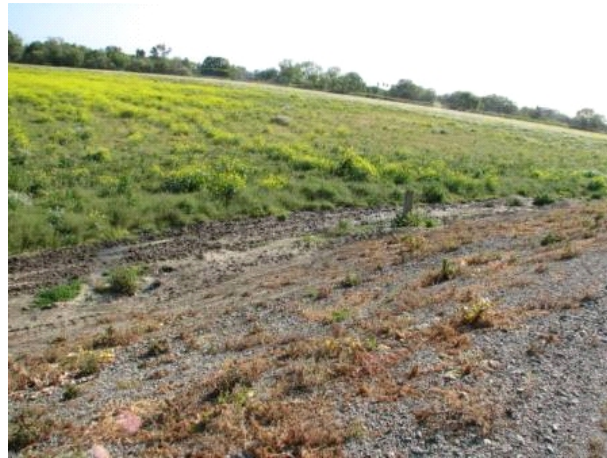
Levee Mile Report Line	1
Start Levee Mile	0.54
End Levee Mile	0.54
Location	Land Side
Category	Earthen Levee
Item	Seepage / Sandboils

LMIR No.	Levee Mile		Category	Item	* Location	** Rating	Action/Comment	GPS Latitude/Longitude		Issue No. Photo
	Start	End						Start	End	
1	0.54	0.54	Earthen Levee	Seepage / Sandboils	LS	U	Inspector Comments: Seepage areas noted. No boils present	37.768451 ° -121.296491 °	37.768451 ° -121.296491 °	8 Y
2	0.66	0.66	Earthen Levee	Encroachments	WS	W	Pipe Inspector Comments: 14" steel irrigation intake with sluice gate.	37.767505 ° -121.294902 °	37.767505 ° -121.294902 °	1 Y
3	0.86	1.42	Earthen Levee	Seepage / Sandboils	LS	U	Inspector Comments: Lengthy seepage area noted, evidence of wet soil and standing water. No boils present.	37.764885 ° -121.293350 °	37.759007 ° -121.299725 °	9 Y
4	1.26	1.26	Earthen Levee	Encroachments	WS	W	Pipe Inspector Comments: 20" irrigation intake, sluice gate on water side hinge point.	37.760574 ° -121.297365 °	37.760574 ° -121.297365 °	2
5	2.29	2.29	Earthen Levee	Encroachments	WS	W	Pipe Inspector Comments: 20" steel rrigation intake.	37.752225 ° -121.296431 °	37.752225 ° -121.296431 °	3

Seepage located at toe of levee

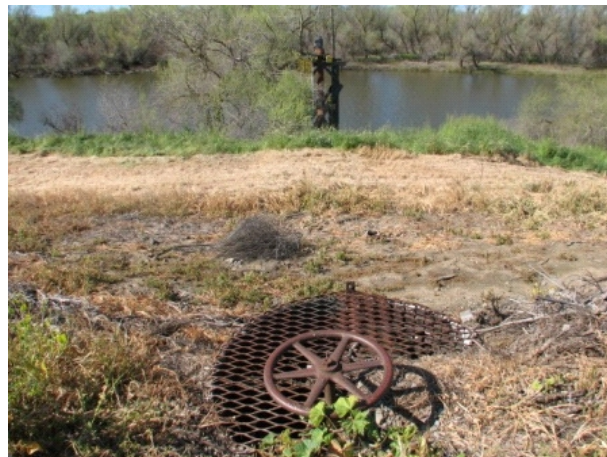
Levee Mile Report Line	2
Start Levee Mile	0.66
End Levee Mile	0.66
Location	Water Side
Category	Earthen Levee
Item	Encroachments

Irrigation intake on San Joaquin River. Positive closure device (sluice gate) on water side hinge points. Pipe is through freeboard portion of levee. Concrete stand pipe beyond landside toe.

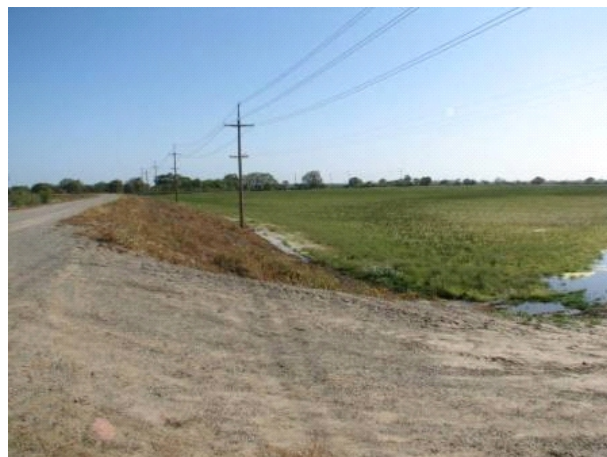
Levee Mile Report Line	3
Start Levee Mile	0.86
End Levee Mile	1.42
Location	Land Side
Category	Earthen Levee
Item	Seepage / Sandboils

Seepage is evident at landside toe.

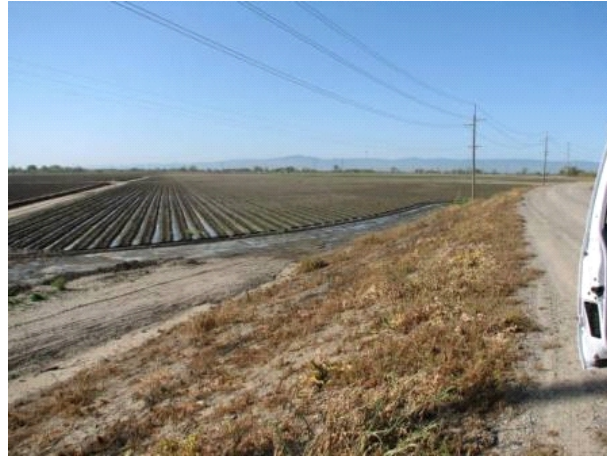
Levee Mile Report Line	3
Start Levee Mile	0.86
End Levee Mile	1.42
Location	Land Side
Category	Earthen Levee
Item	Seepage / Sandboils
Continued evidence of seepage extending from levee toe into field.	
jeto_s_20110412_376.jpg

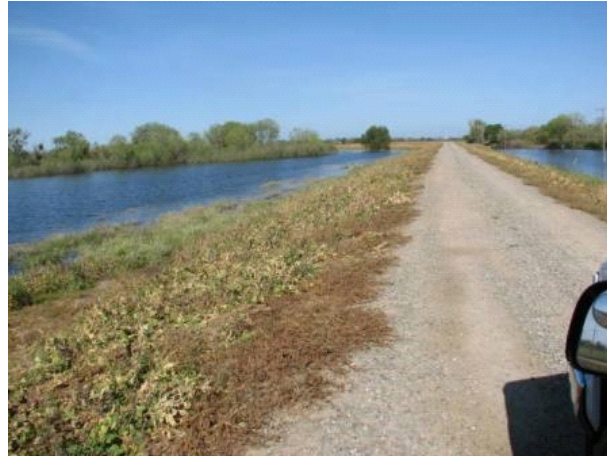
Levee Mile Report Line	1
Start Levee Mile	0.00
End Levee Mile	0.46
Location	Water Side
Category	Earthen Levee
Item	Vegetation

LMR No.	Levee Mile		Category	Item	* Location	** Rating	Action/Comment	GPS Latitude/Longitude		Issue No.
	Start	End						Start	End	Photo
1	0.00	0.46	Earthen Levee	Vegetation	WS	W	Control annual grass and weeds on the levee slopes and easements. Inspector Comments: 04/12/2011 Vegetation has been sprayed, will be dragged once they have completely died.	°	°	1
								°	°	Y

Vegetation has been sprayed and is dying, area will be dragged once vegetation has died.
